Tech Bulletin – 2 – Tilt Arms

CRITICAL INSTALLER TECH NOTE 2: For all Dealer/Installers:

Tilt Support Arm - LOWER ATTACHMENT

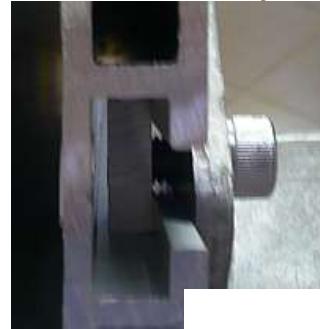
1. Correct use of the tilt arms requires split washers with the M8x20mm bolts on the LOWER attachment points . . . using a ribbed washer is incorrect and allows the end of the bolt to contact the back of the aluminum first, such that the square nut has little if any effect or grip. This can cause the array to tilt or come loose, especially in high winds.

WRONG BOLT M8x16mm
wrong ribbed lock washer
no bolt end showing and bolt does not penetrate square nut

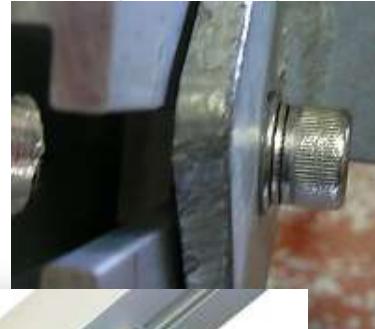
WRONG BOLT M8x16mm
wrong ribbed lock washer
no bolt end showing and bolt does not penetrate square nut

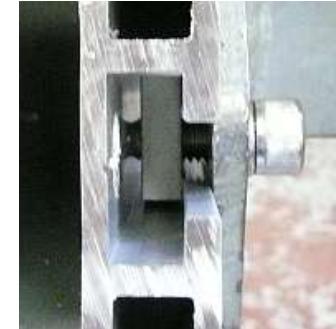
WRONG WASHER M8x20mm
wrong with ribbed lock washer
end of bolt touches rail

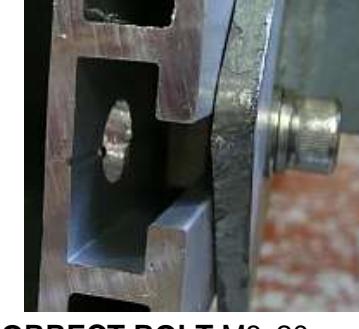
CORRECT BOLT M8x20mm
Washer & Correct Split lock washer
end of bolt visible

NOTE: FOR SECURITY
Use 3 Square Nuts
1 x M8x20mm SHCS, Split lock washer and Flat washer
2 x M8x16mm SHCS Split lock washer and Flat washer to prevent “creep” caused by wind buffeting. Torque 36ftlb (48nm)

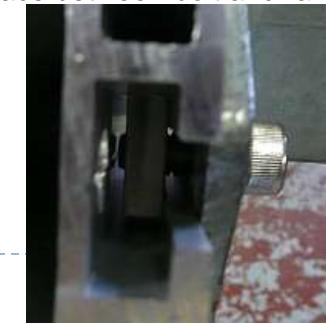
CORRECT BOLT M8x20mm
Space between bolt and rail when torqued

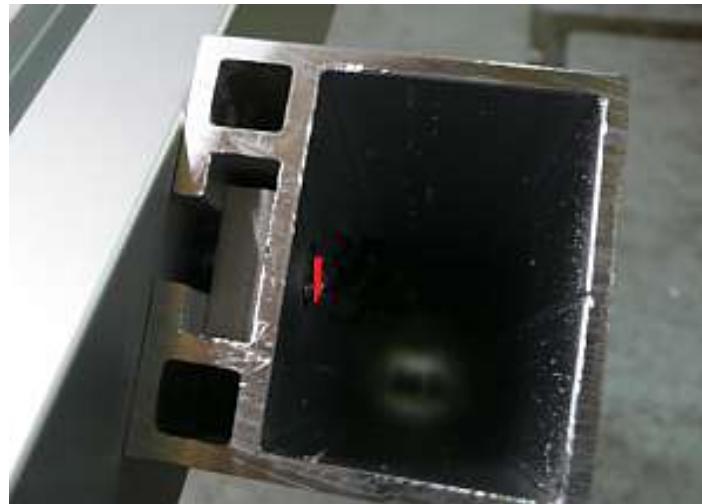
WRONG BOLT M8x24mm

no way to add safety nut

See red mark bolt can fall out

2. The upper attachment bolt M8x30mm must have a flat washer/ribbed washer combination on the bolt before inserting in the rail and a nylock nut on side the rail box. The nylock nut should be snug but not hard tightened against the inner surface of rail since it's purpose is to ensure the M8x30mm bolt cannot fall out if it becomes loose or not properly tightened.

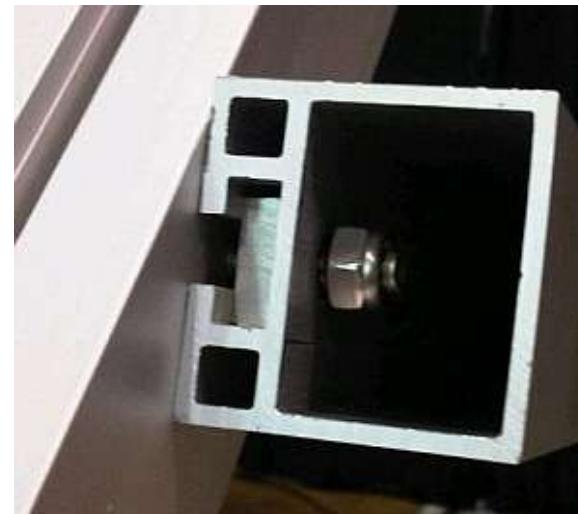
CORRECT BOLT M8x30mm

with nylock safety - un-torqued or loose square nut cannot fall out

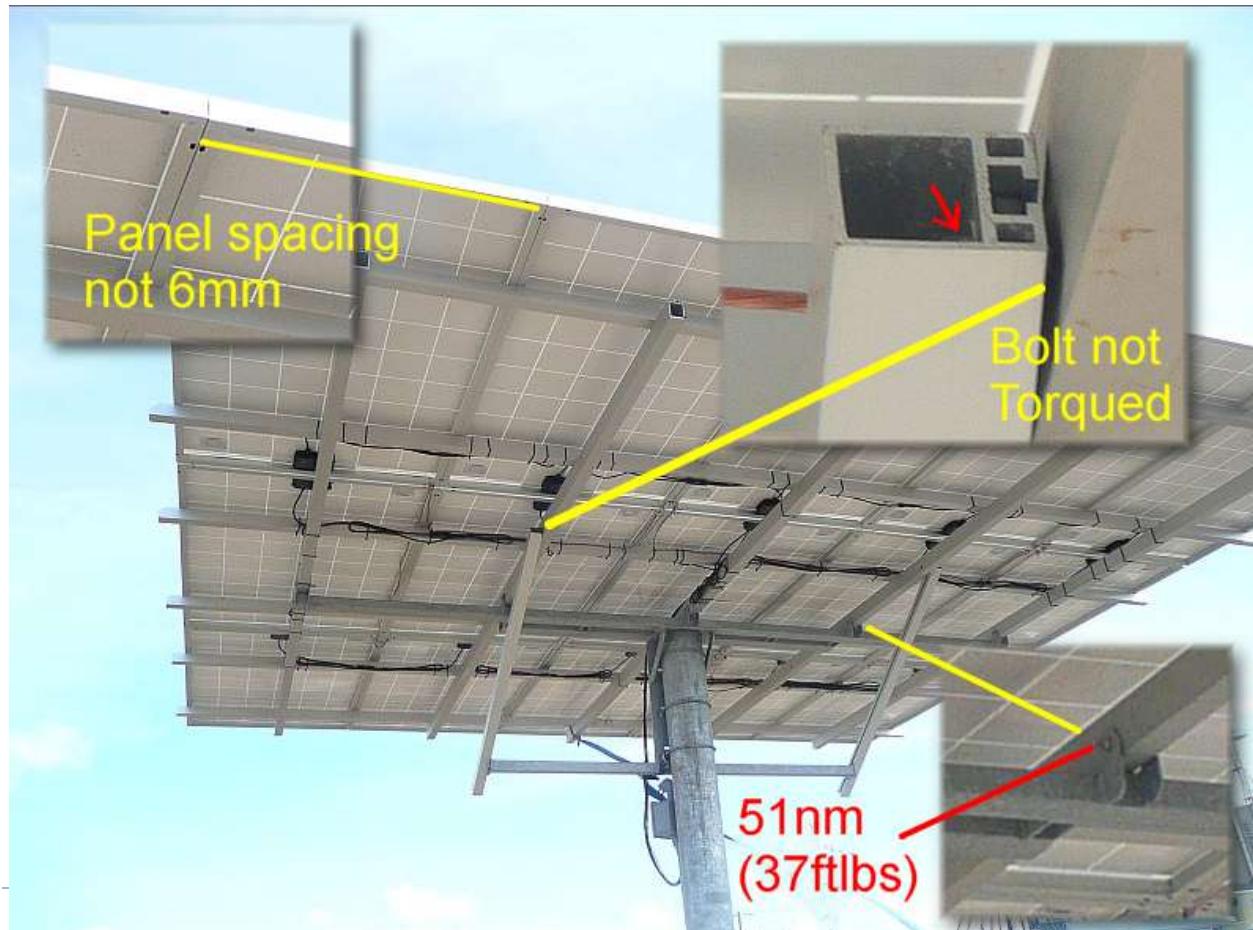
This way the array will remain immovable and secure under windy condition. (notice also RED arrow, missing nylock nut)

3. Whenever an installation is complete any ANYTIME a partially completed array is left unattended the main tilt bolts must be torqued to 37ftlb (51nm)
