Tech Bulletin – 2 – Tilt Arms

CRITICAL INSTALLER TECH NOTE 2: For all Dealer/Installers:

Tilt Support Arm - LOWER ATTACHMENT

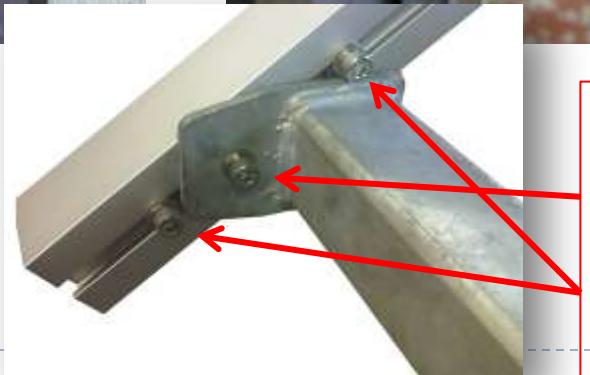
CORRECT BOLT M8x20mm
Washer & Correct Split lock washer
end of bolt visible

NOTE: FOR SECURITY
Use 3 Square Nuts
1 x M8x20mm SHCS, Split lock washer and Flat washer
2 x M8x16mm SHCS Split lock washer and Flat washer to prevent “creep” caused by wind buffeting. Torque 36ftlb (48nm)
